REMOVE AND PREVENT BIOFILMS IN COOLING TOWERS

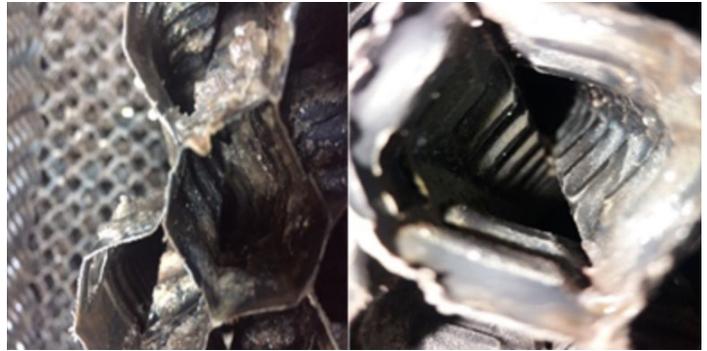
Biofilm and FOG form on the visible surfaces in a cooling tower over time. Offline cleaning was necessary every three months to remove the organic contamination and biofilms by manual cleaning methods, e.g. jet washing and vacuuming. It was successful in removing most of the visible contamination. Still, the contamination in the hidden parts of the system like pipework and heat exchangers was more challenging. Microbiological control was difficult to control with bromine, and high levels (5-7ppm total bromine) were needed to keep sessile bacteria concentrations levels within parameters.

Fill pack before and after, notice the absence of biofilm on the after picture.

BOC added proportionally to make up water after an initial shot dose to establish correct concentrations. Dosing concentrations are usually based on BOD, FOG and suspended solids data. On commencing dosing, COD levels rose after addition of the BOC, and this was attributed to the product dissolving the insoluble organic material and in particular the FOG, which reduced dramatically. It made control of the bacterial loading more of a challenge. Still, a COD range of 200-250ppm found to be the limit whereby a balance between clean up and bacterial compliance achieved while a clean-up of the system was continuing.

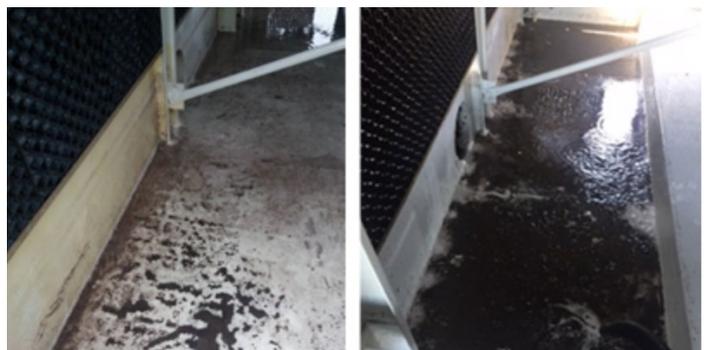
After the first month inspection to the tanks which typically have considerable amounts of debris, the photos show the before and after conditions with an estimated 95% reduction on organic fouling. The surfaces felt less slimy, and the staining of the GRP surfaces was beginning to fade. Over successive inspections, conditions have continued to show immaculate conditions. Bacterial control is also much more stable due to less biofilm and sludge available for recontamination of the system.

Typical Organic Sump contamination on the right, contamination after BOC treatment.

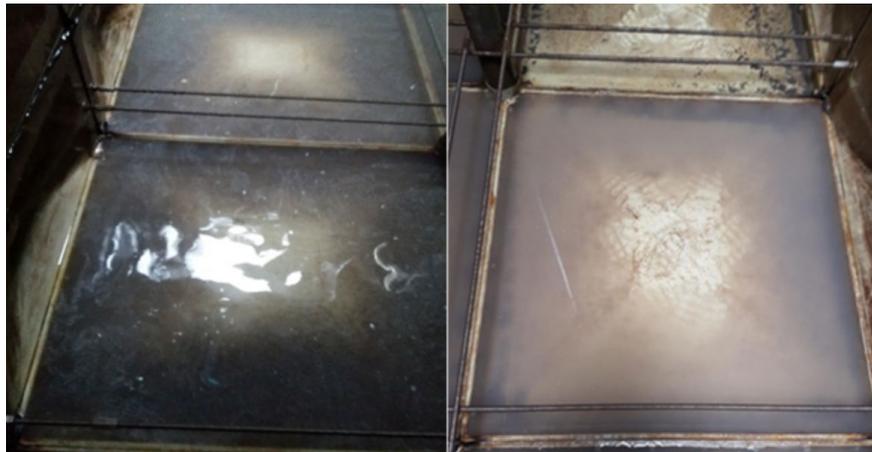
The program has been running successfully for two years, maintenance and reduced water consumption has resulted in a financial saving of over 75%. The pictures below are recent (Easter 2020) and show clearly the effect in the use of the BOC.

After the first month inspection to the tanks which typically have considerable amounts of debris, the photos show the before and after conditions with an estimated 95% reduction on organic fouling. The surfaces felt less slimy, and the staining of the GRP surfaces was beginning to fade. Over successive inspections, conditions have continued to show immaculate conditions. Bacterial control is also much more stable due to less biofilm and sludge available for recontamination of the system.

Before and after, prior to treatment is on the left, treated on the right.
