Balboa Island/Little Island Pump Station

Odor Control & Grease Cap Treatment

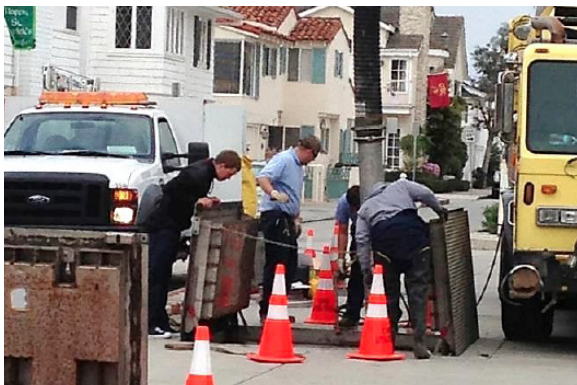
Vacuum Cleaning of Pump Station

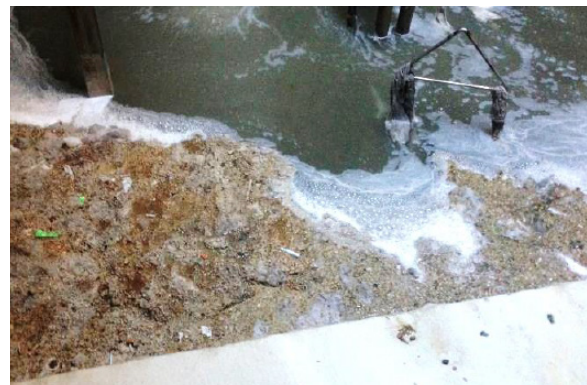
Breaking the Floating Grease Cap

- **03/06/13:** In order to further improve grease cap formation, a hole was drilled in sewage discharge pipe within well to allow better circulation. Remaining grease cap further reduced, but still forming in corners of well. Decision to install better turbulence and aeration with regenerative blower.

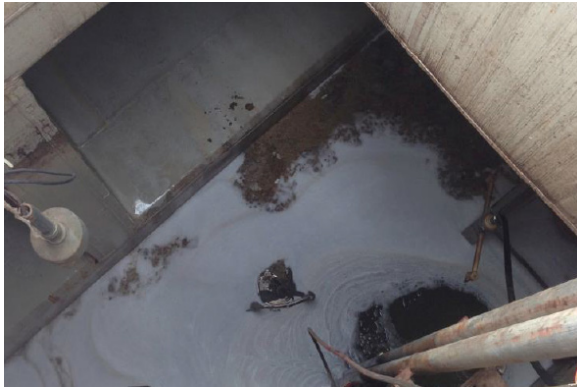
Accelerating Breakdown of Grease Cap

- **03/08/13:** 1.5 hp regenerative blower installed in dry well. 1.5 inch reinforced tubing connected through existing PVC pipe, with another section of tubing running down to one side of well. Dosage rate reduced 4.5 GPD. Water usage reduced by 60% (2 minutes per cycle).

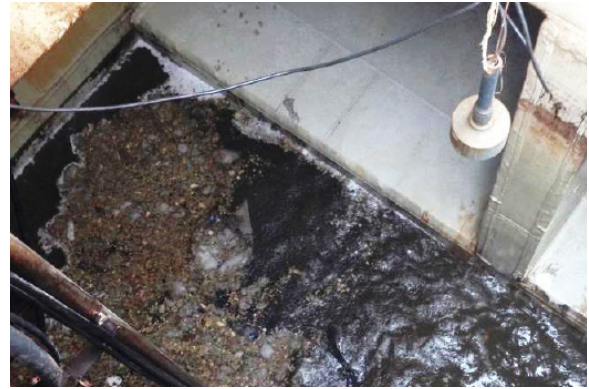
Highly Degraded Floating Grease Cap

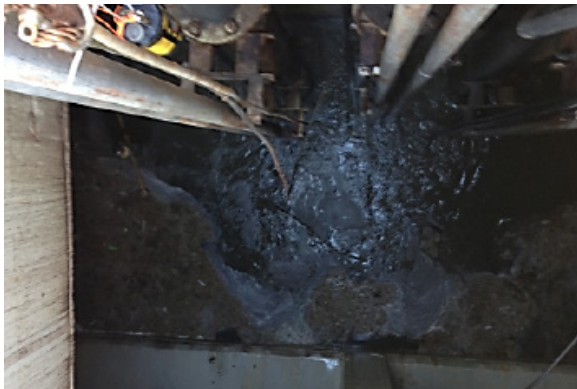
**Without Air Blower
Slight Grease Cap in Corners**

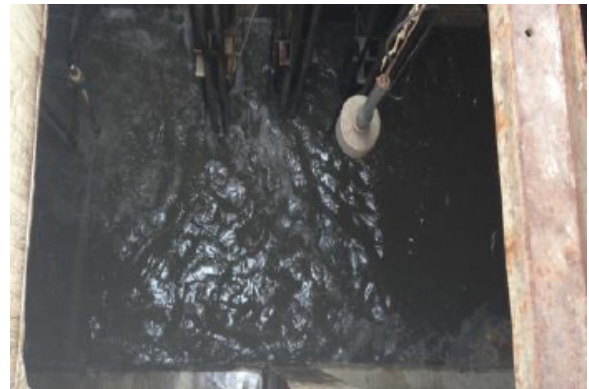
**With Air Blower
No Grease Caps Remaining**

- **03/20/13:** Product dosage reduced to 3.5 GPD. Grease cap formation substantially reduced, except for small accumulation in far corner opposite of blower tube outlet. OdaLogger recording continued 0 – 1 ppm H₂S readings.
- **03/27/13:** A second tubing was installed in well with a bifurcation fitting at PVC outlet. Increased circulation immediately cleared remaining floating grease in corners. Dissolved oxygen meter recording 7.8 ppm of DO in well.
- **04/06/13:** Product dosage reduced down to 1.6 GPD with no detriment to break down floating grease cap formation. Spray cycle reduced down to 30 seconds per cycle (95% reduction in water usage). OdaLogger readings recording average 0 – 1 ppm H₂S.
- **Through 05/09/13:** Well continues to show no formation of grease cap or H₂S odors. New installation deemed successful.
